CASE STUDY

Flat Roof Waterproofing project in Manilla, Philippines

MARISEAL SYSTEM®

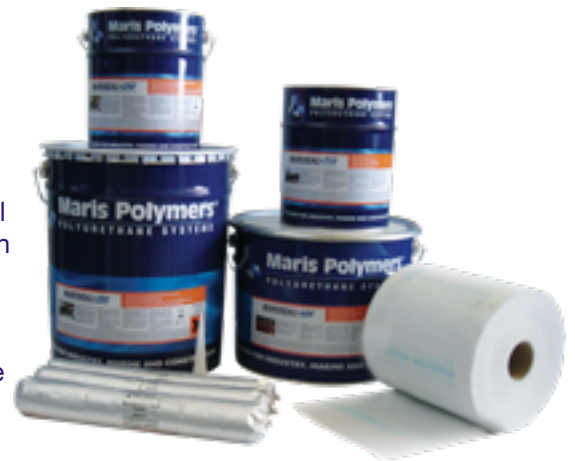
The MARISEAL SYSTEM® consists of different products, dependent on the roofs characteristics. In this case the system applied consisted of the MARISEAL AQUA-PRIMER, the certified one component polyurethane liquid waterproofing membrane MARISEAL 250 and the aliphatic polyurethane top-coat MARISEAL 400.

The Manilla Tennis Club is one of the most prestigious colonial buildings in the city. The roof of this building needed a renovation as the old bitumenfelt was leaking. The MARISEAL SYSTEM was selected to be applied over the old bitumenfelts and waterproof the roof once and for all.
